Why is API 653 Relevant to AP5A?

Philip Myers, Director PEMY Consulting, LLC.

Session Code Tu-G2

26th California Unified Program
Annual Training Conference
February 26-29, 2024

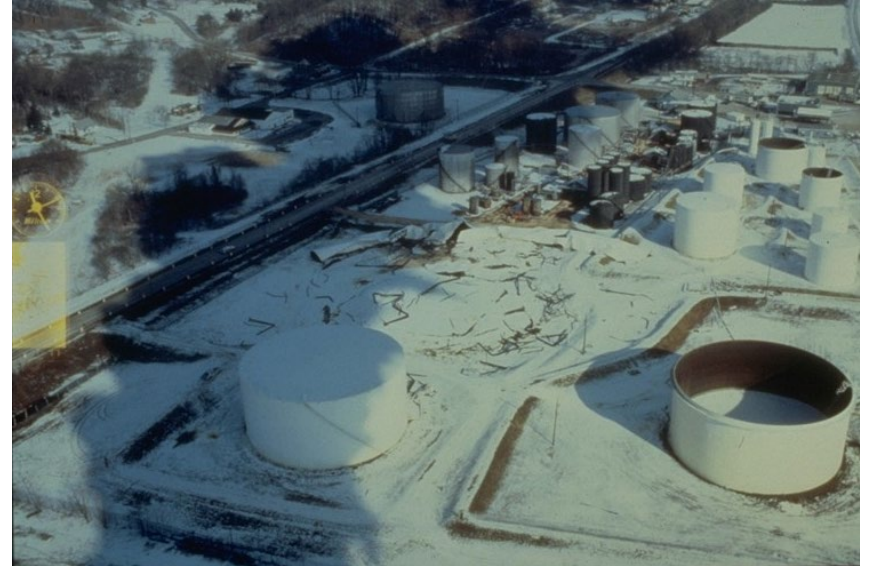
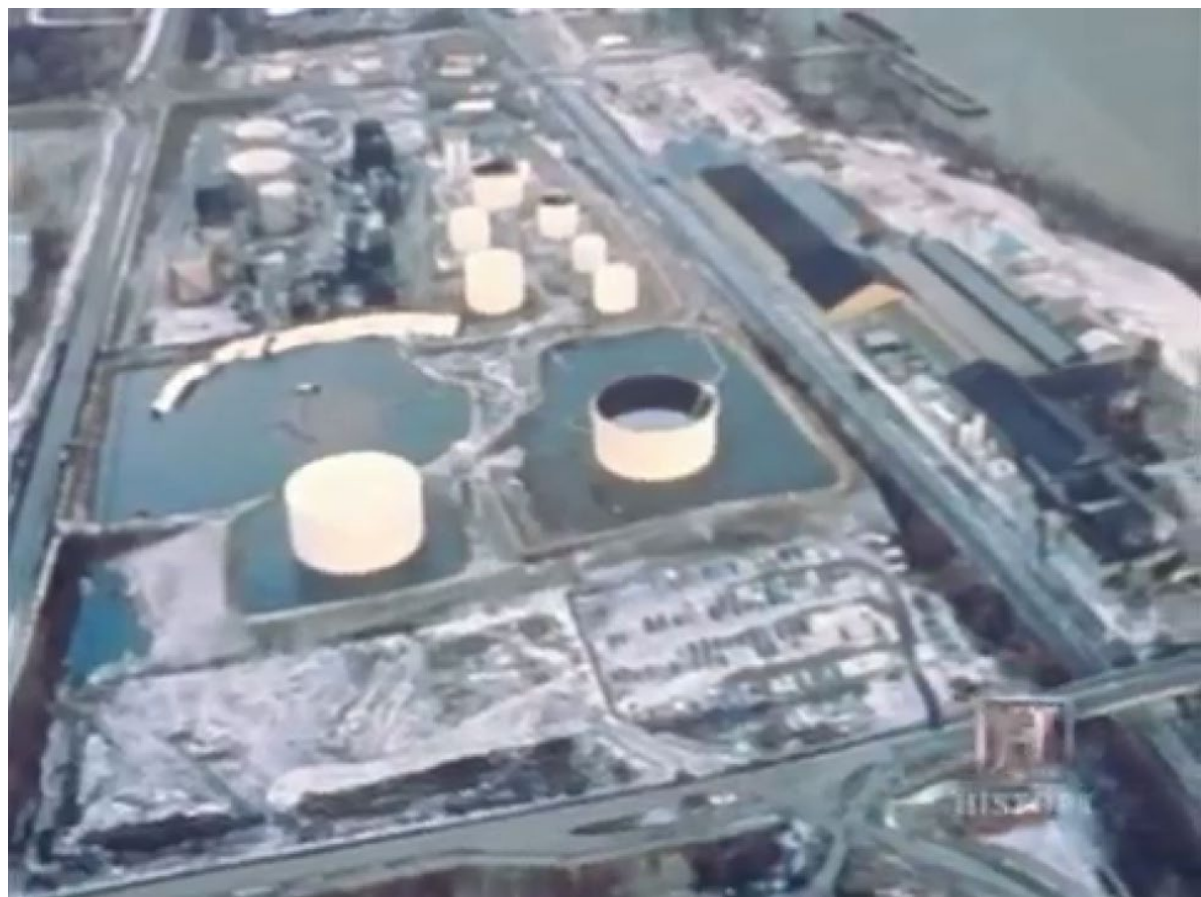
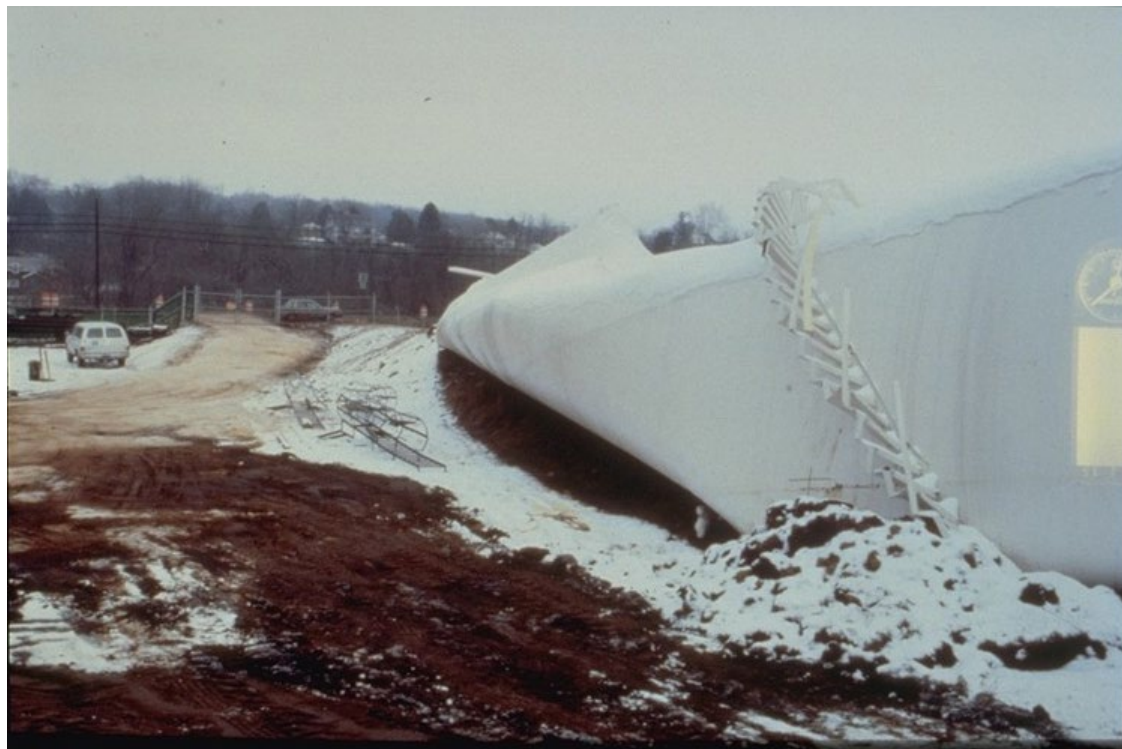
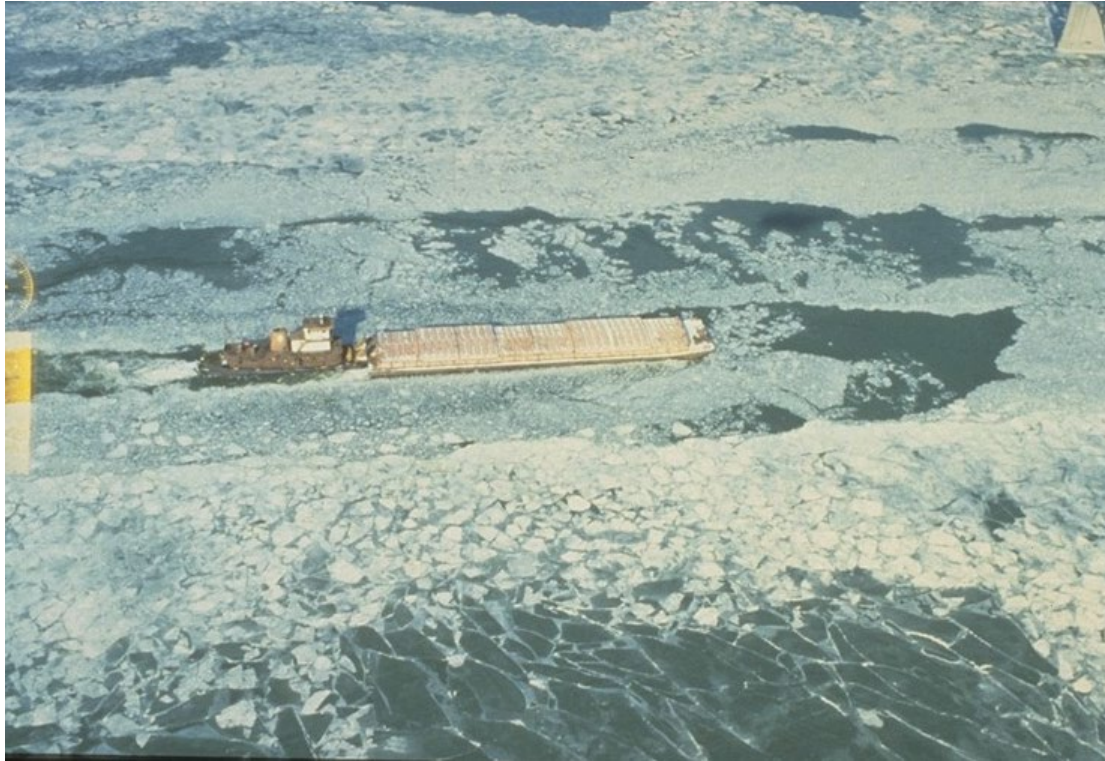
The Ashland Oil Incident
January 2, 1988

- January 2, 1988
- Recently reconstructed tank was filled completely with diesel. 4M gallons.
- Extreme cold, -12F
- Sudden catastrophic failure of the tank – Brittle Fracture
- All contents released, spilled over dike, and into Monongahela River then to Ohio River.

1/2 to 1 million gallons spilled into river. \$2M fine.

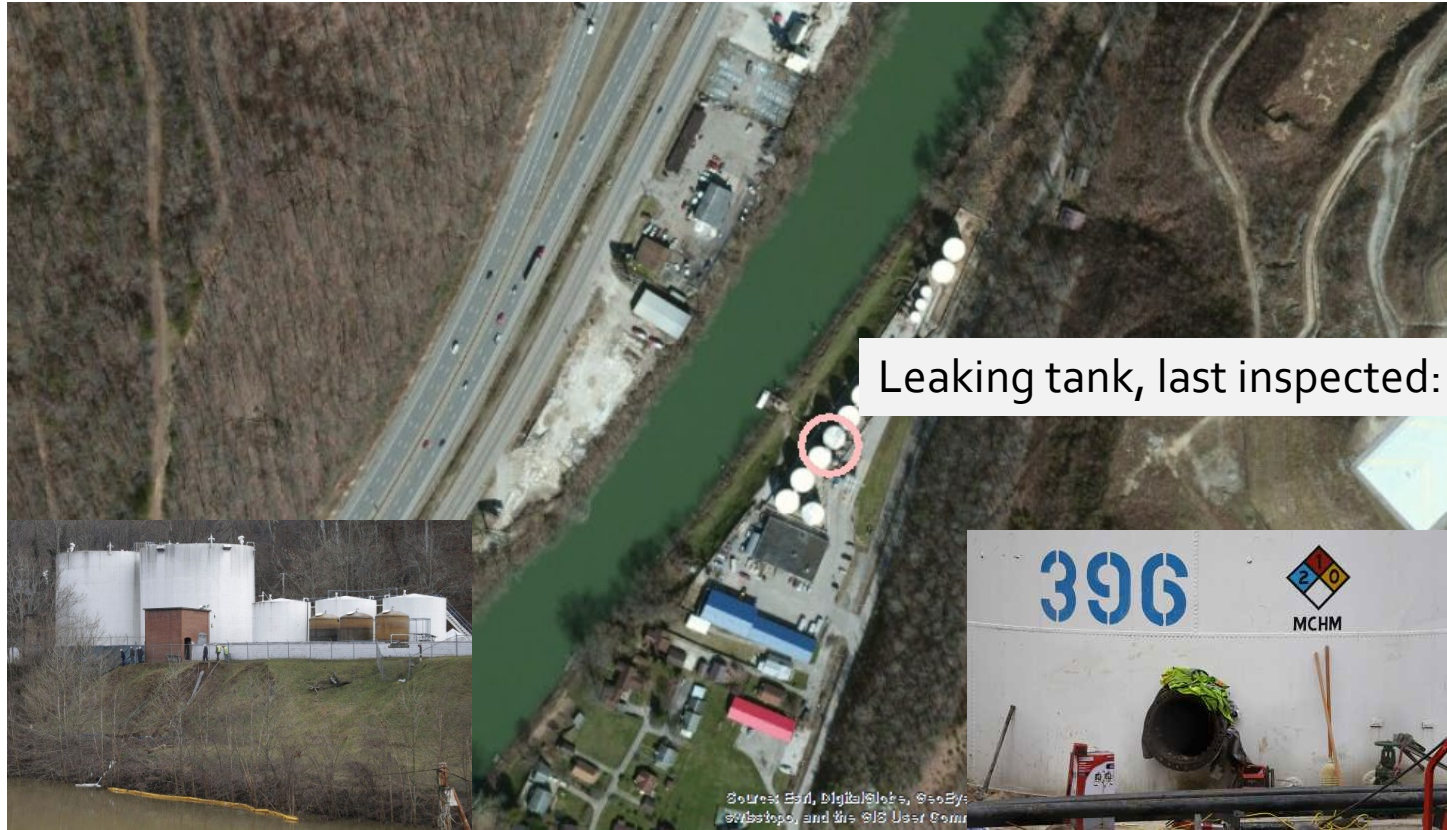
API 653 Inspections?

Leaking tank, last inspected: 1965

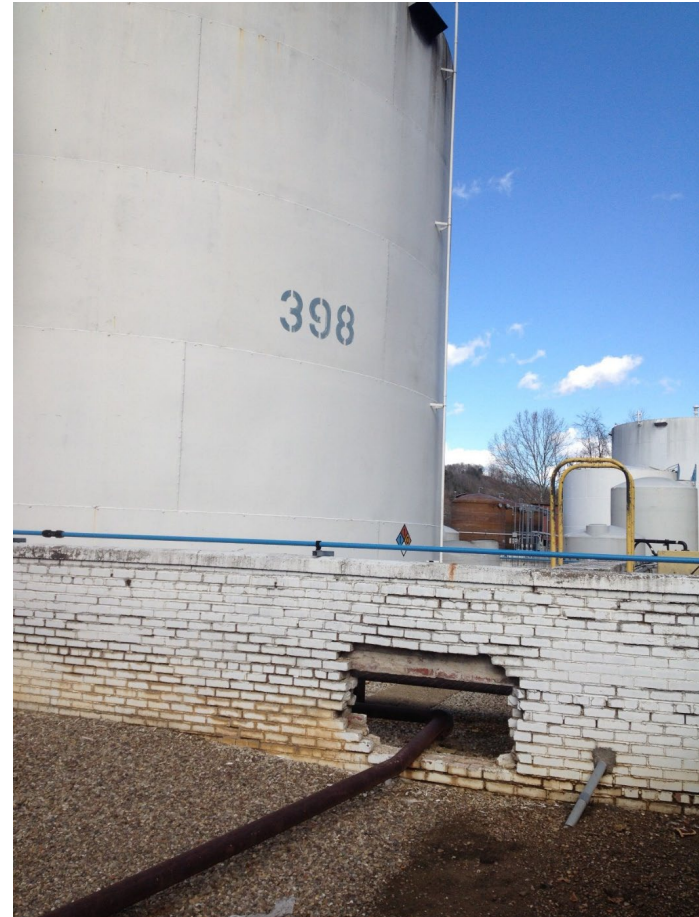
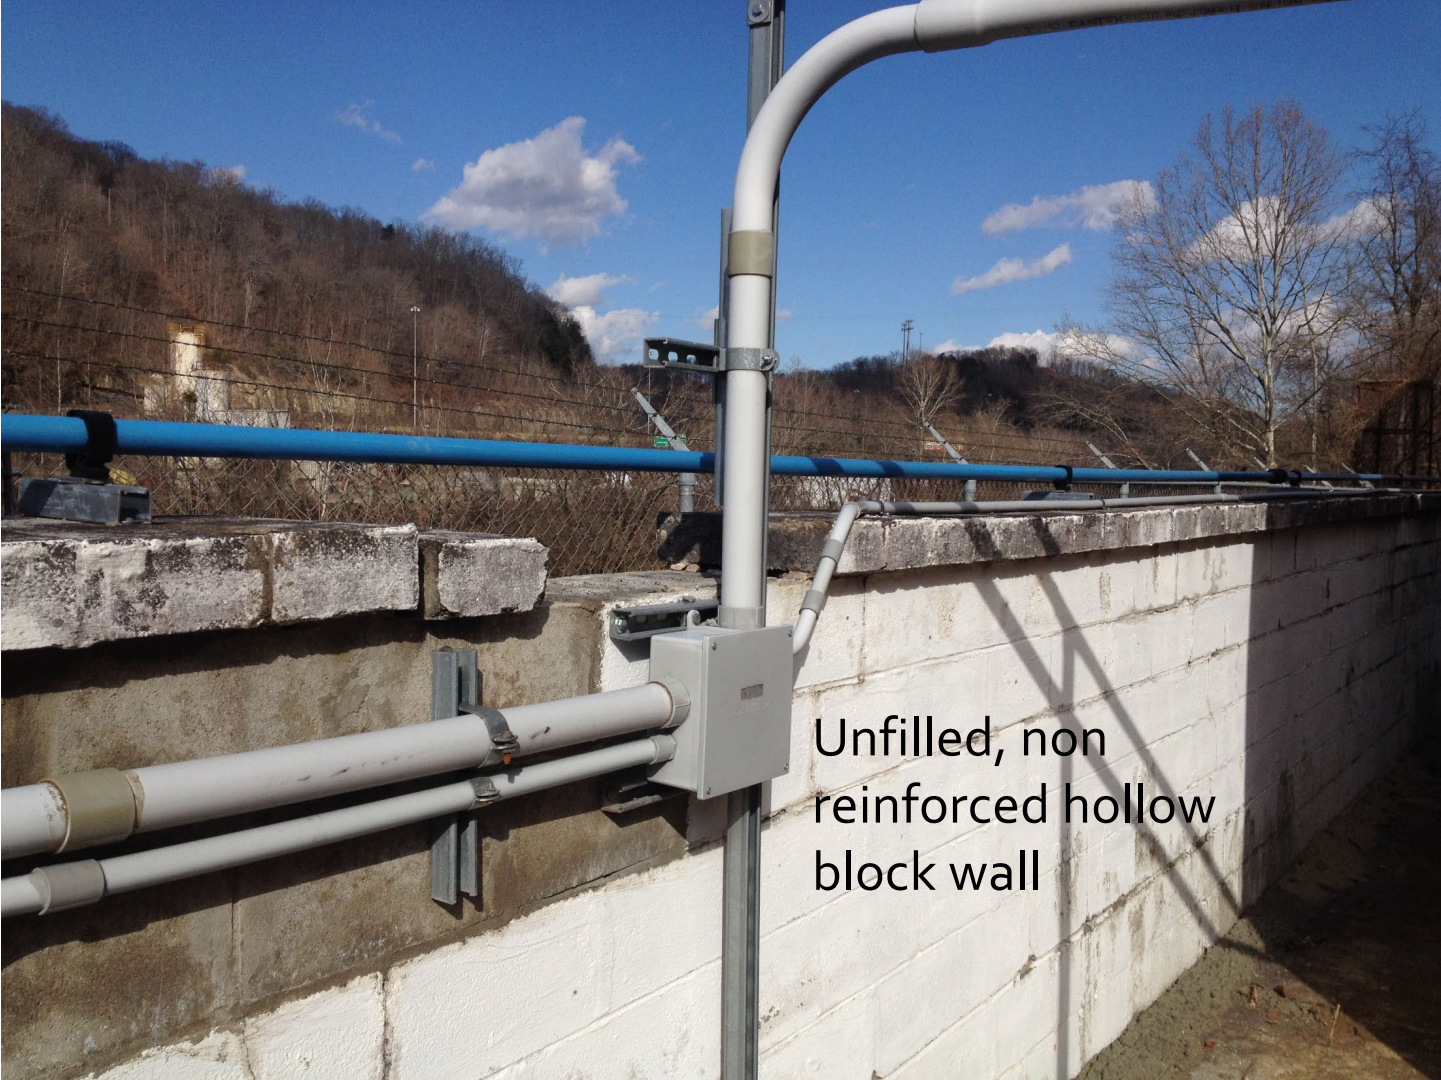
- What is the purpose of secondary containment?
- Did Freedom know the purpose?
- As a new employee would you ask your boss why the hole is there? Would you exercise stop work authority if your company allowed it?
- What would you do?

Unfilled, non
reinforced hollow
block wall

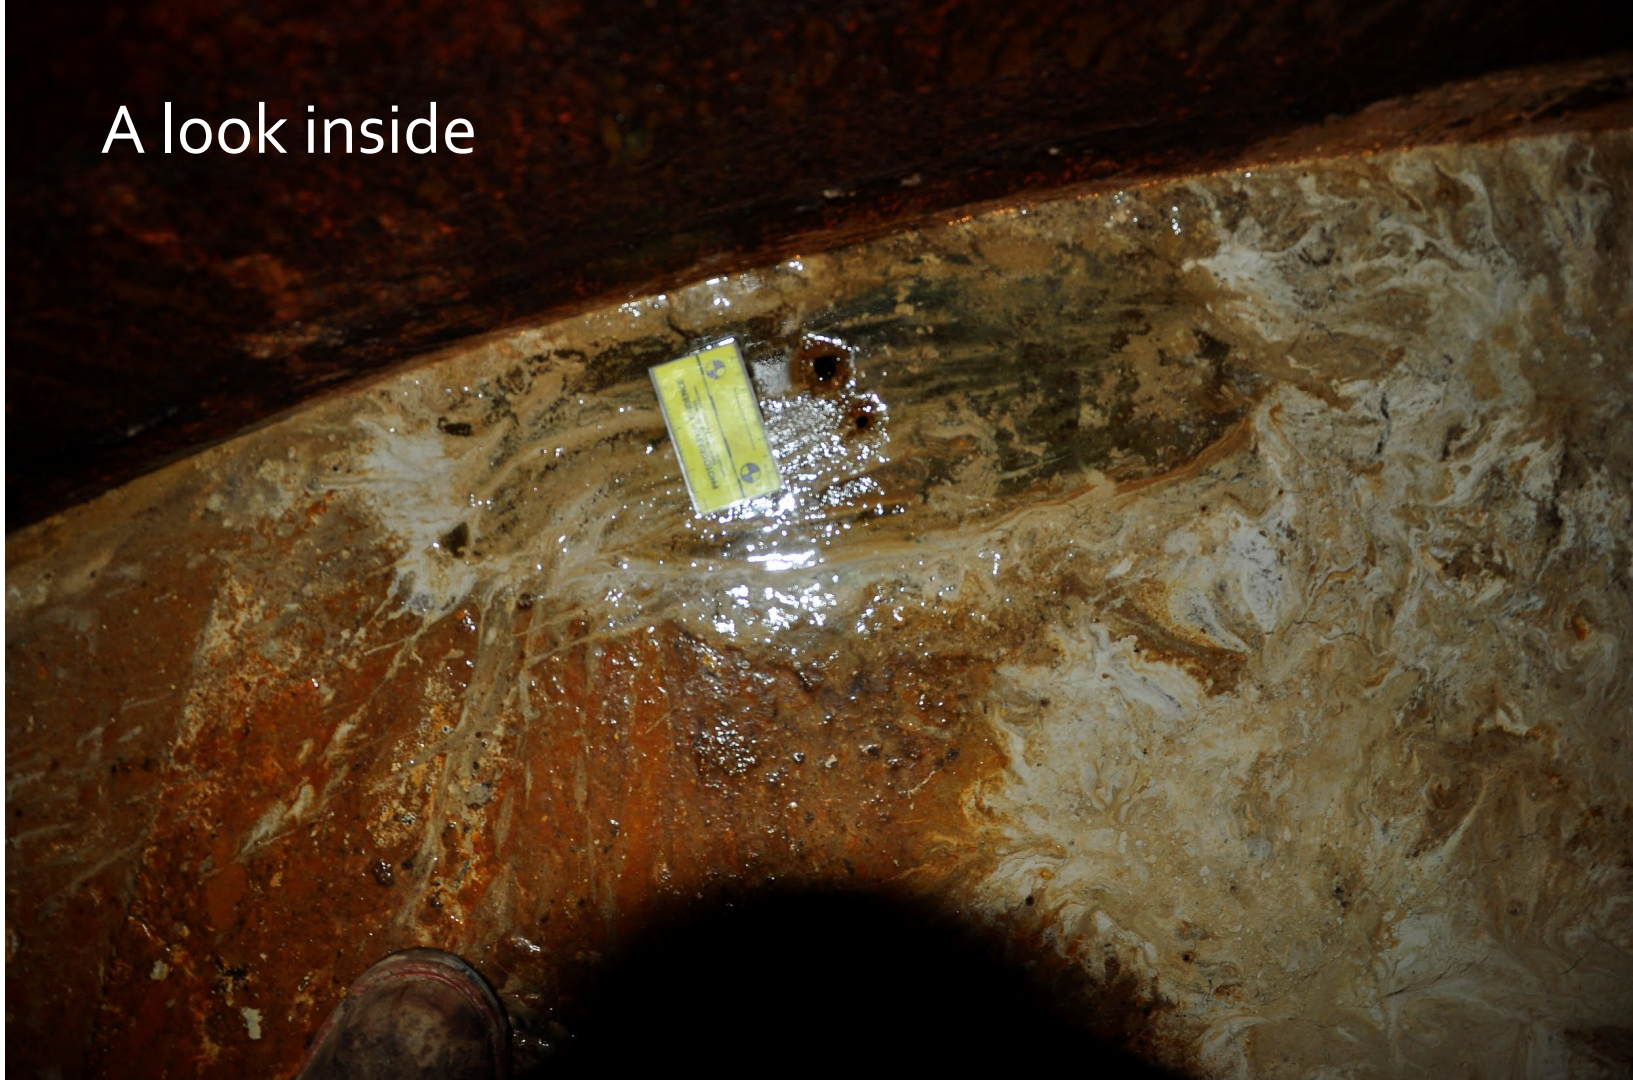
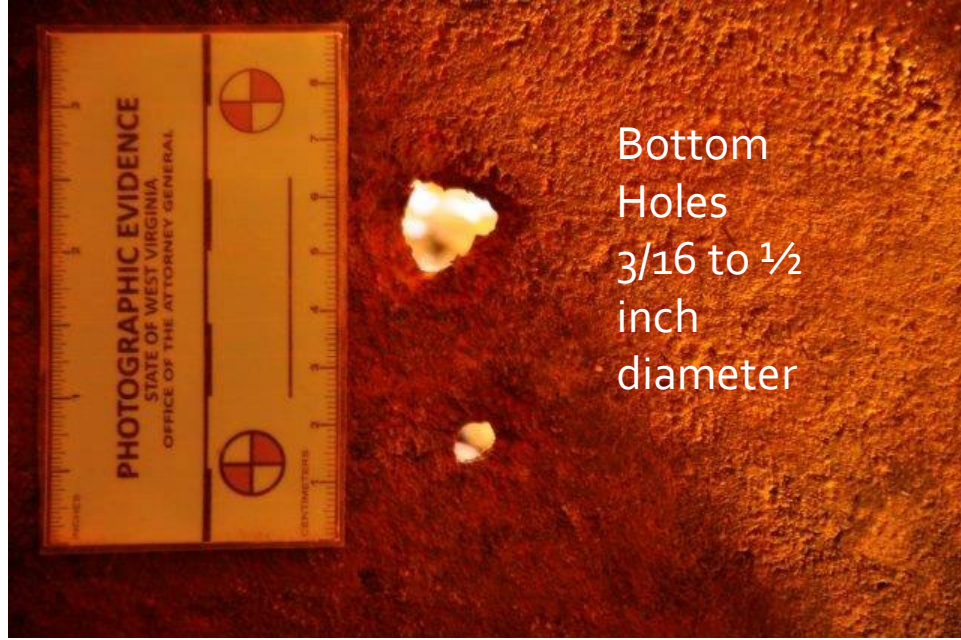
A look inside

Bottom
Holes
3/16 to 1/2
inch
diameter

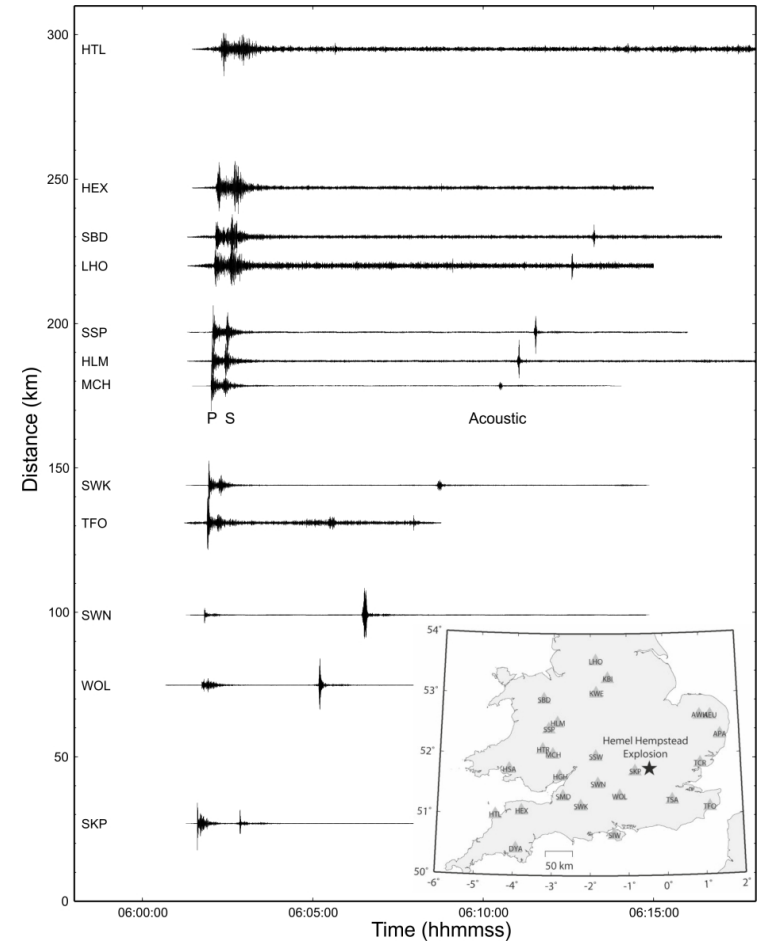
Seismograms

- The explosion was detected on seismograph stations in the UK and the Netherlands
- Largest explosion in peacetime Europe
- Rough estimate 29.5 tons TNT equivalent

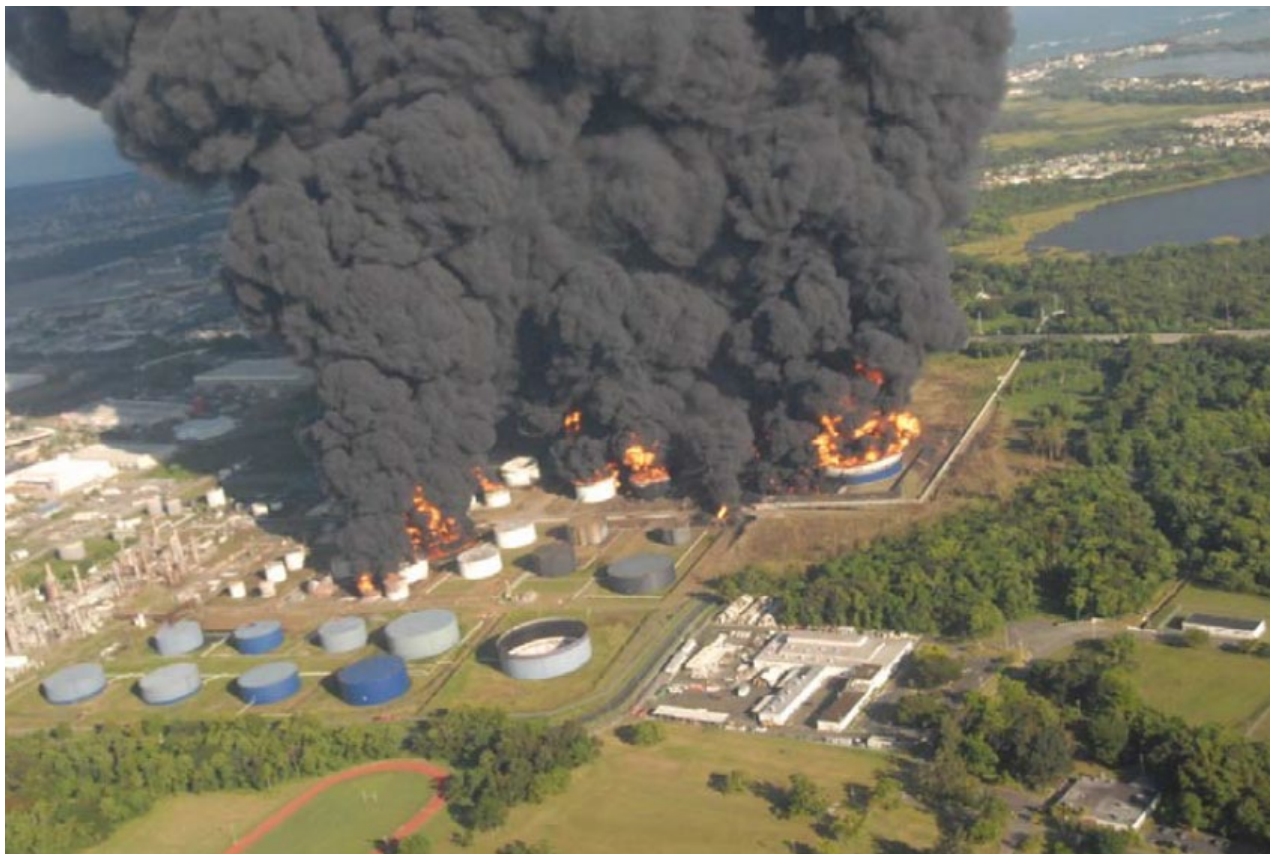
Overflow went on for 26 minutes dumping about 200,000 gallons of gasoline on the ground before the VCE

One operator at dock while another monitoring at terminal. At 10 pm T411 reached max level and T409 was opened to the 7000 gpm flow. Operator estimated T409 filled at 1am. At 11 pm operator confirmed from the side gauge that T411 would be filled at 1am. But it started to overflow between 11pm and midnight.

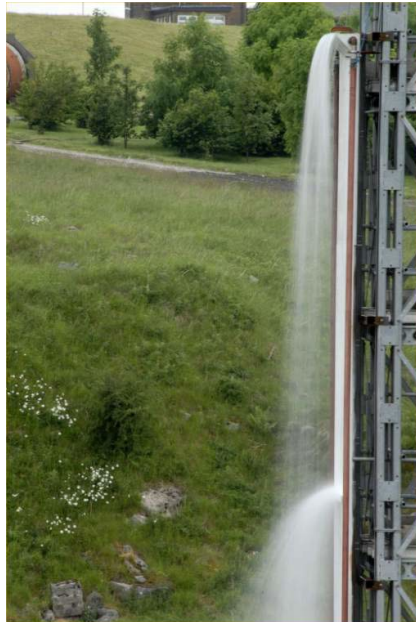
Figure 14b: Comparison between cascade droplet structure in water (left) and decene (right) in similar conditions

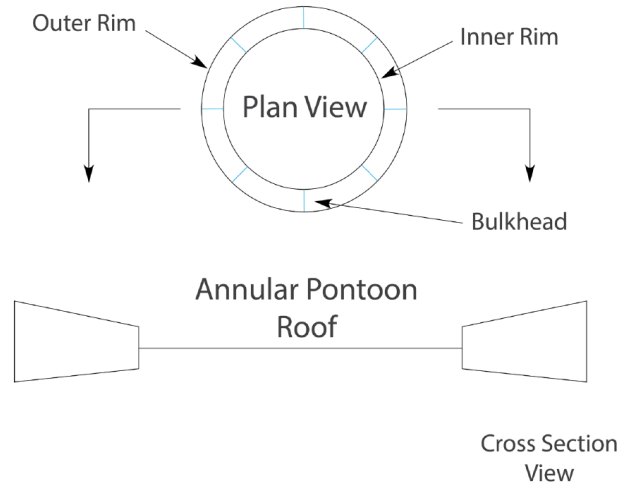
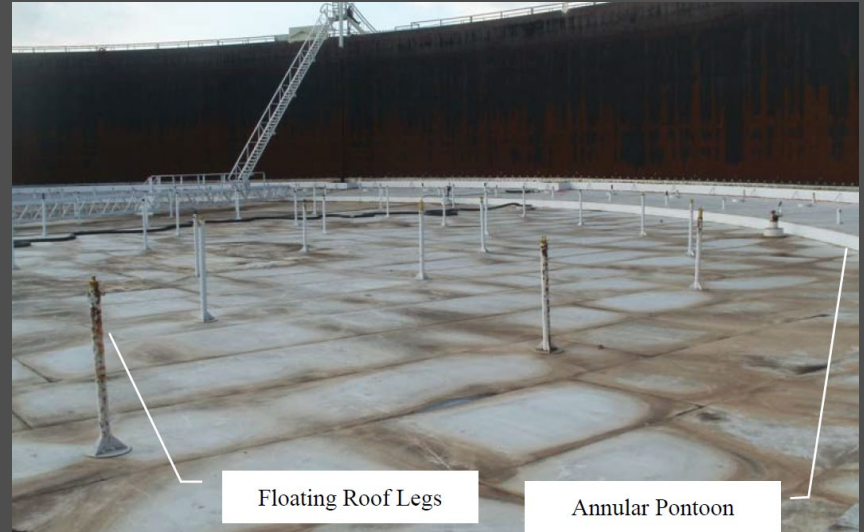
Figure 5 Schematic of an APFR

Schematic of an APFR

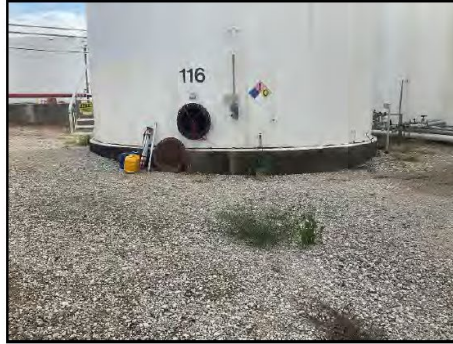
001 Grade Surrounding Tank Foundation

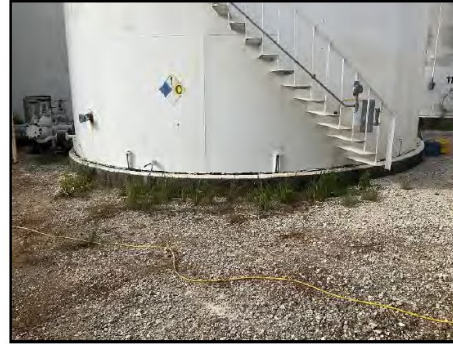
002 Grade Surrounding Tank Foundation

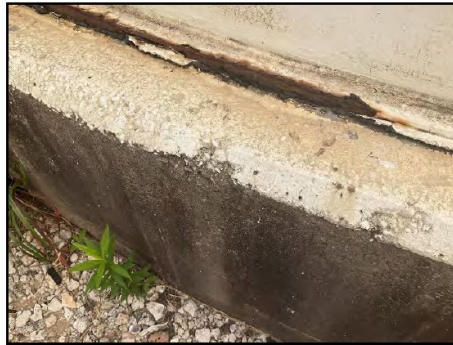
003 Spalling on Ringwall

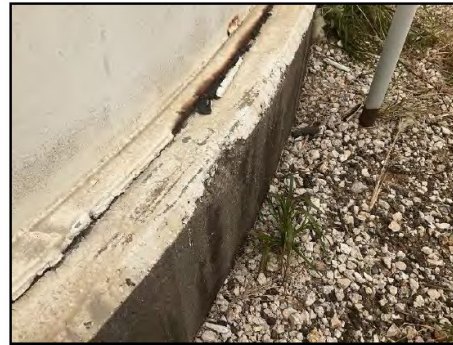
004 Spalling on Ringwall

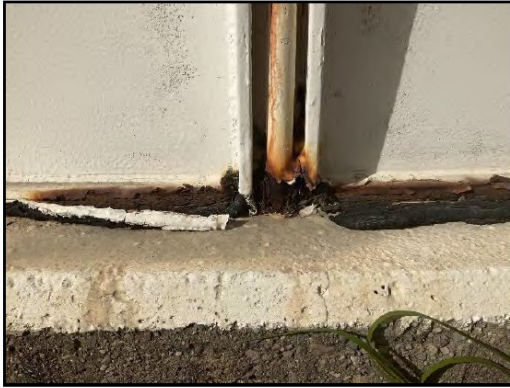
031 Active Corrosion on Anchor Chair X

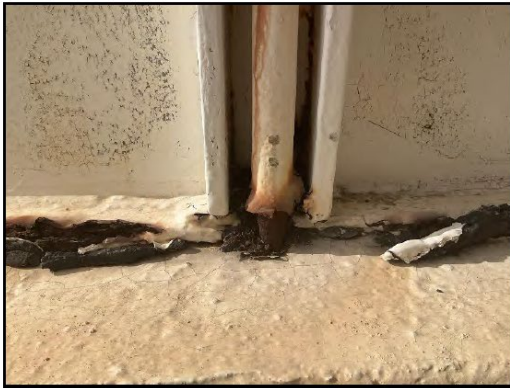
033 Active Corrosion on Anchor Chair Z
